Manhole Inspection Summary

Manhole # S37C__049MH

Insp Date: **10/20/08 9:24 AM**

Location Address: **410 front st**

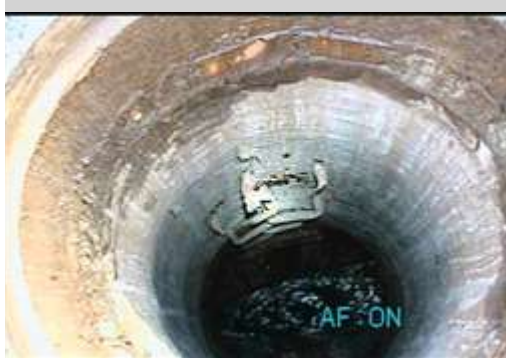
Defect 1

Count: **8** Missing: **3** ☒ **Corroded**

corr steps

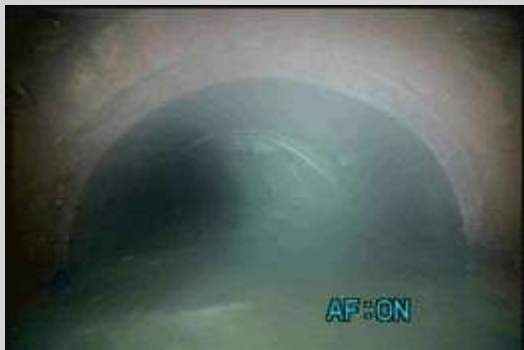
12 O'Clock Outflow

steamy

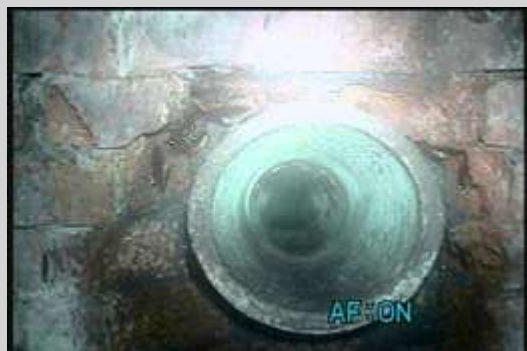
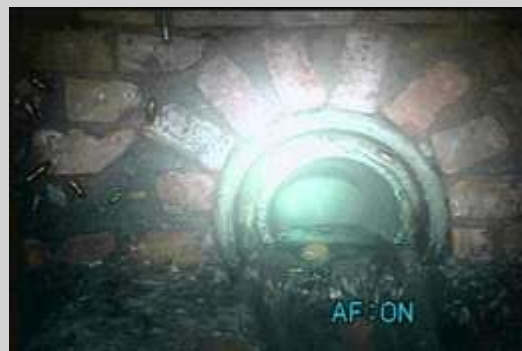
9 O'Clock Inflow

Drop: **Outside Direct**

Drop Condition: **Open**
